DESIGN AND EVALUATION OF HYDRAULIC LIME GROUTS FOR *IN SITU*
REATTACHMENT OF LIME PLASTER TO EARTHEN WALLS

A THESIS

Historic Preservation

1998

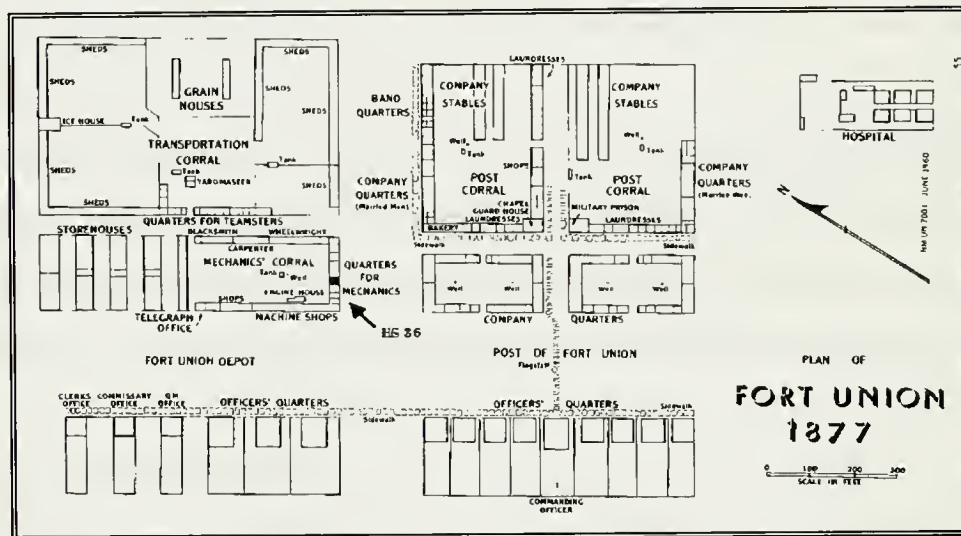
Figure 1. Plan of Fort Union in 1877. HS 36, known as the Mechanics Corral, was the area selected by the NPS for plaster conservation treatment. The darkened area is room 24, where one of the adobe samples analyzed in this testing program was taken. (from Utley, 1962)

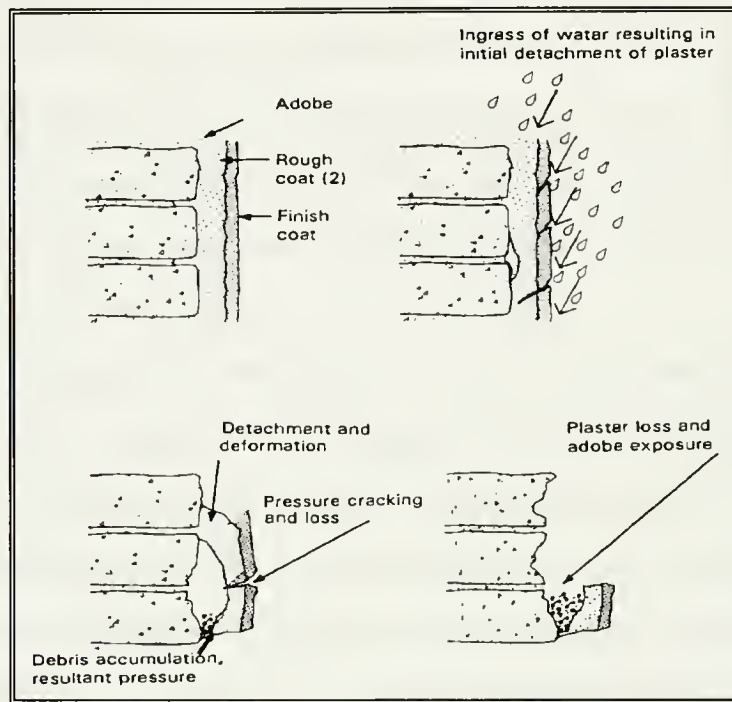
Figure 2. Schematic of plaster detachment processes at Fort Union NM.
(from Matero 1995, 14; designed by Maribel Beas)

The principal deterioration mechanism causing loss of adhesion and detachment of the Fort Union plasters was the infiltration of water behind the plaster. As water penetrated through cracks or along broken edges of plaster, it softened the adobe, causing it to lose cohesion and weaken the bond between the plaster and the supporting adobe wall. Eventually, the partially unsupported plaster deformed and became displaced, forming a void where loose debris could accumulate. The stress caused by this action progressively led to more cracking and eventual plaster loss. Secondary deterioration mechanisms were the intrinsic weakness of the bond between lime and adobe, made worse by poor quality of original construction achieved by untrained army personnel who knew little about durable adobe construction.

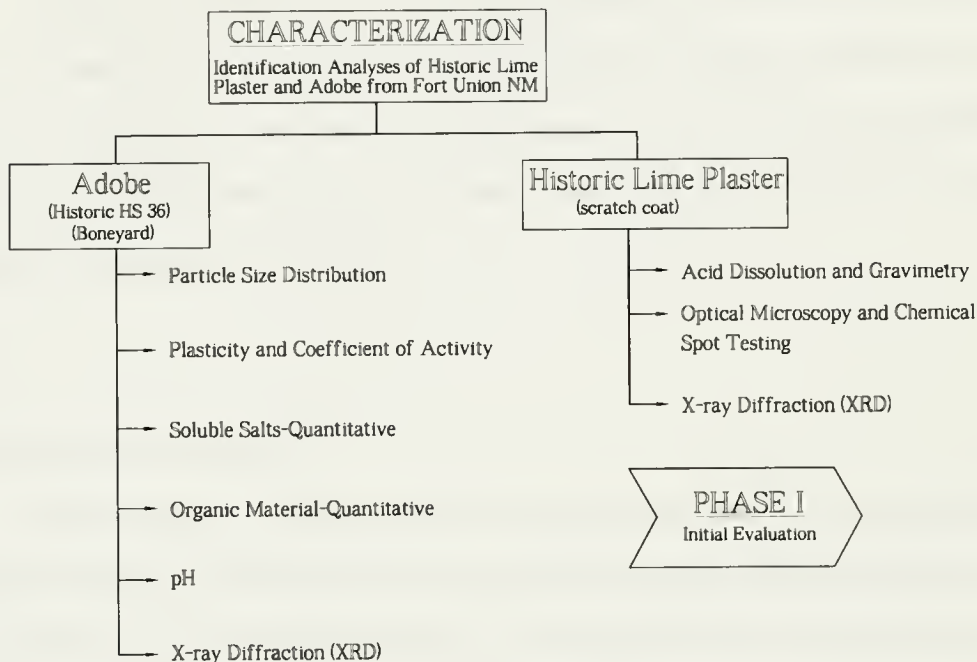
Figure 3. Flow chart of characterization tests conducted on Fort Union adobe and plaster samples

1. carbonate content by acid dissolution and gravimetry
2. examination of stratigraphy by optical microscopy
3. identification of sulfates by microchemical spot testing
4. determination of crystalline components by X-ray diffraction (XRD)

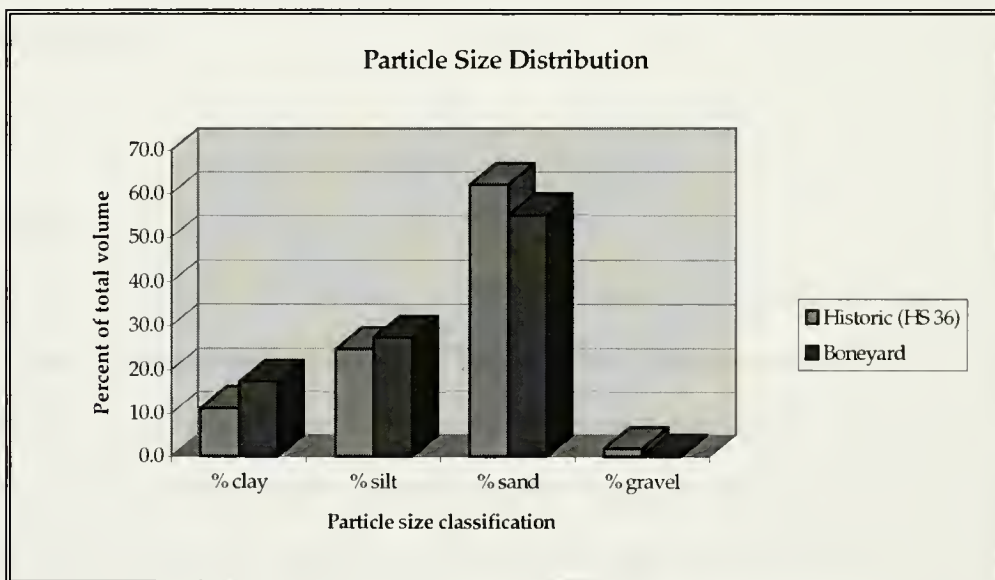
Figure 4. Adobe particle size distribution graph

Discussion - The results of the particle size analysis show that the HS 36 sample is composed of 62% sand, 25% silt, and 11% clay (weight percentages). The Boneyard sample consists of 55% sand, 27 % silt, and 17% clay (weight percentages). According to the Unified Soil Classification System (Wagner 1957), the soil in both adobe samples is considered coarse and is classified as a silty sand.

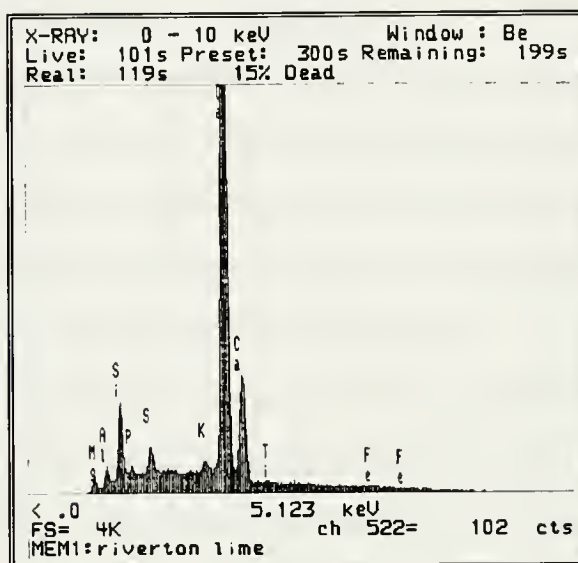
Figure 5. SEM/EDS spectrum of Riverton hydrated hydraulic lime (from Matero 1995, 98)

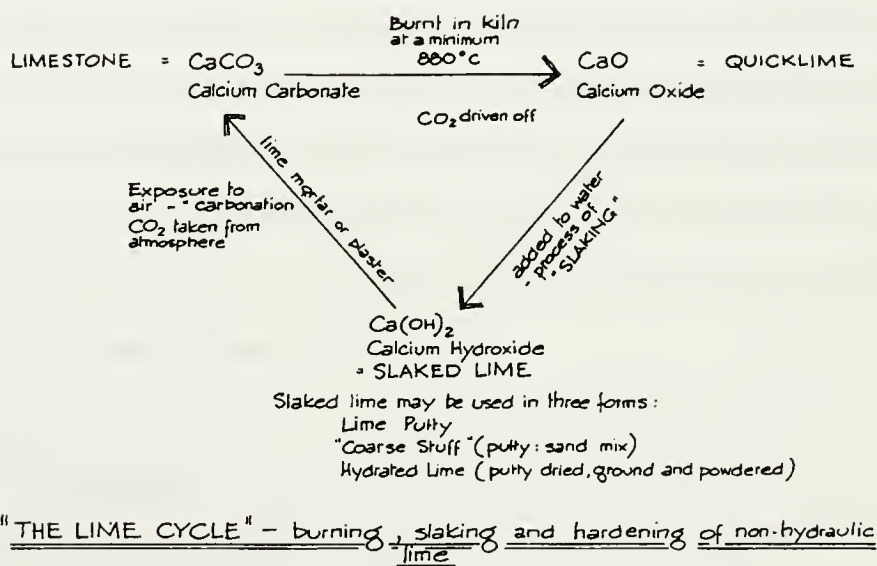
Figure 6. The lime cycle --burning, slaking, and setting of non-hydraulic lime (Ashurst 1988, 2)

The lime cycle for non-hydraulic lime is as follows:

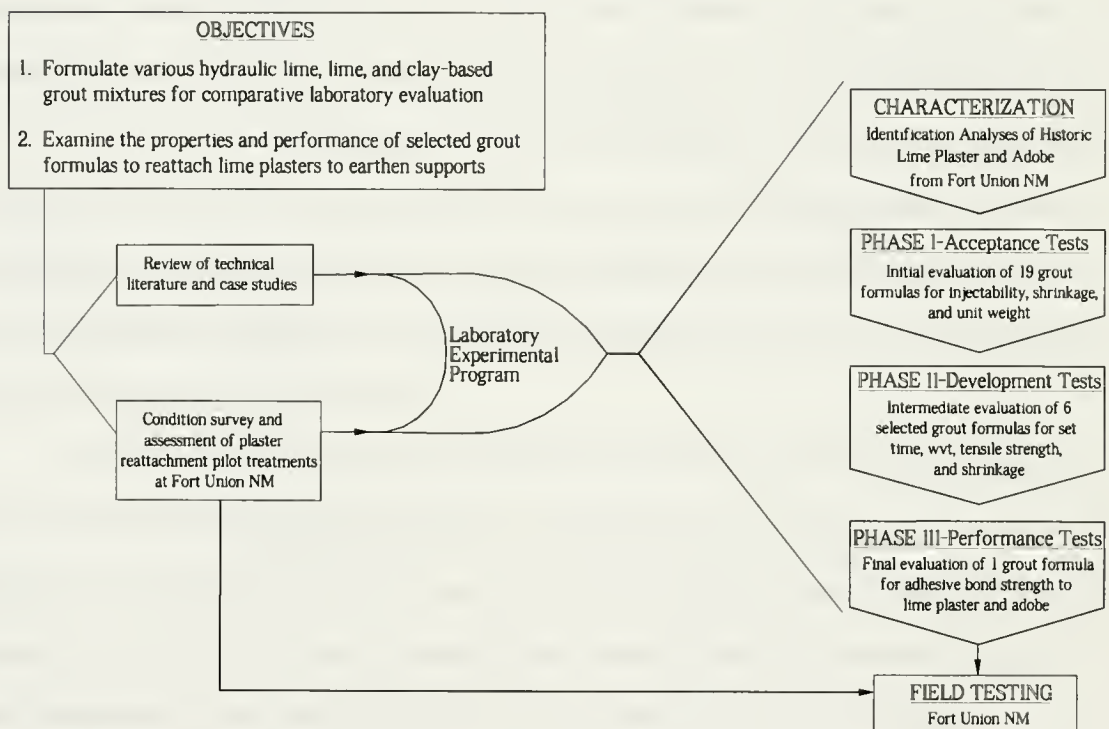
Figure 7. Experimental program activity flow chart

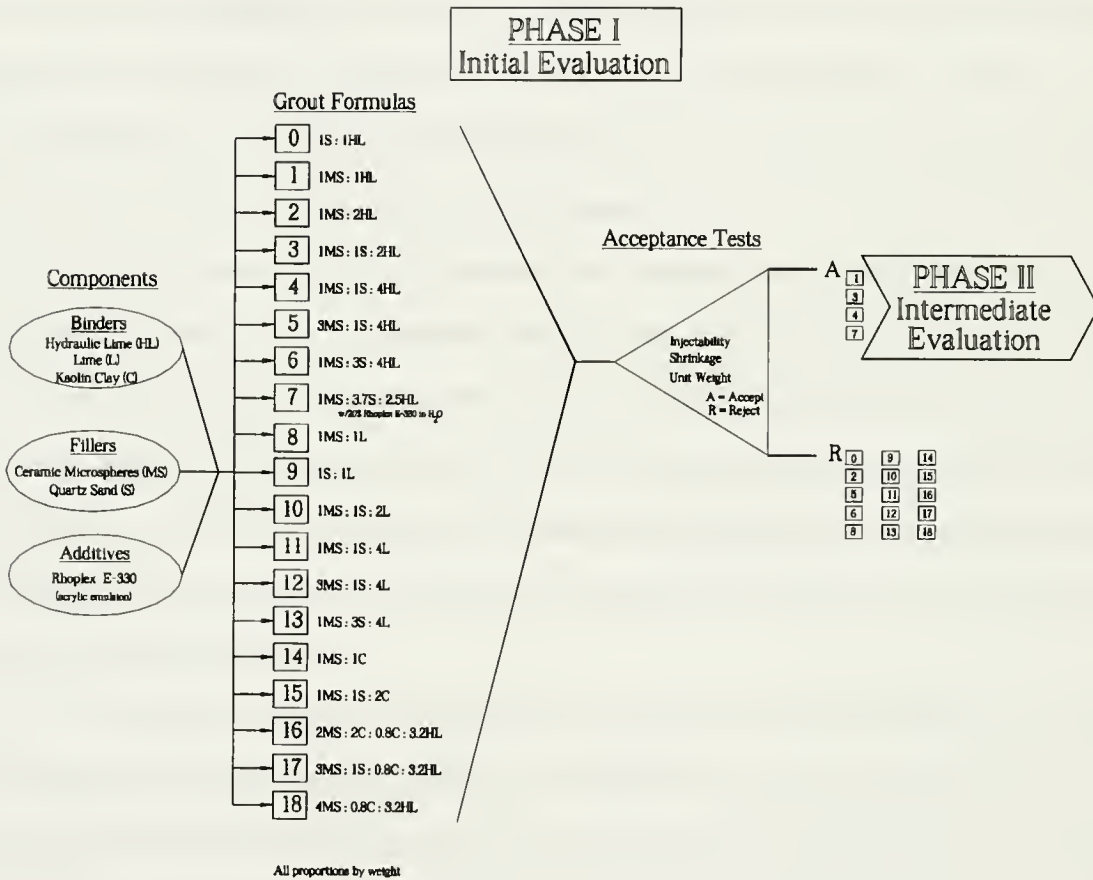
Figure 8. Phase I activity flow chart

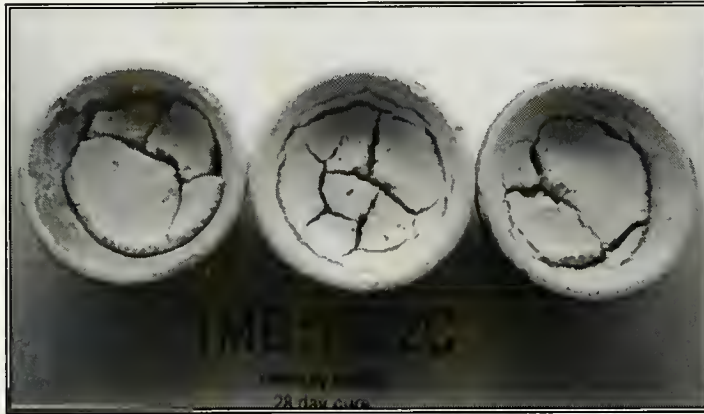
Figure 9. Phase I shrinkage test. Sample #15 with clay as the binder. Note extensive concentric cracking and shrinkage. At initial pour the grout was filled to the rim of the dish.

Most of the grout formulas exhibited some form of shrinkage cracking. Three principal cracking patterns were observed: *concentric cracking* -- long, continuous cracks on the surface and

within the grout, that often spiraled out from the center; *perimeter cracking* -- where the grout contracted uniformly towards the center and detached from the rim of the clay dish; and *straight line cracks* -- narrow, short, straight cracks that formed on the surface just after initial set.

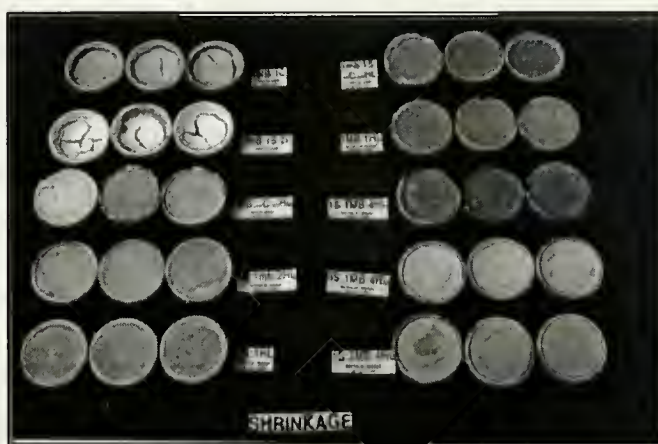
Figure 10. Phase I shrinkage test dishes after 28 day cure

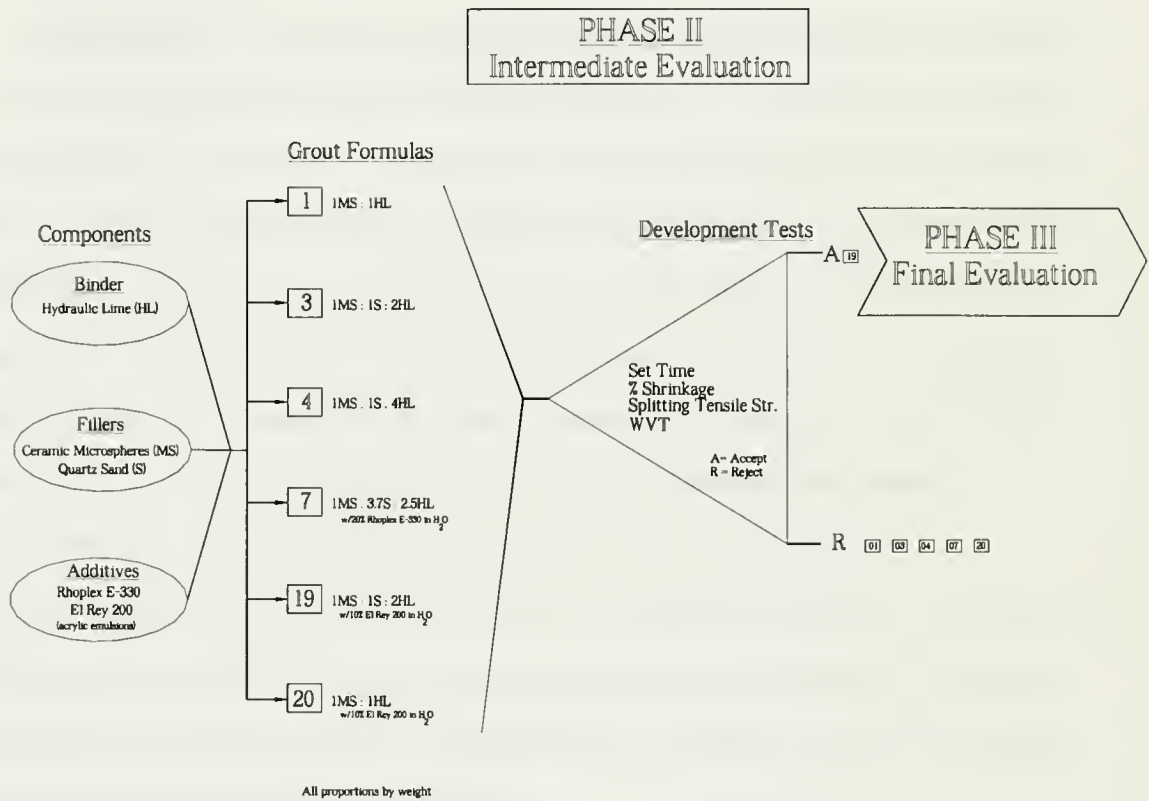
Figure 11. Phase II activity flow chart

For two of the tests, water vapor transmission and splitting tensile strength, samples of the historic adobe were included to serve as a reference standard. Samples of historic lime plaster were not included because not enough material was available.

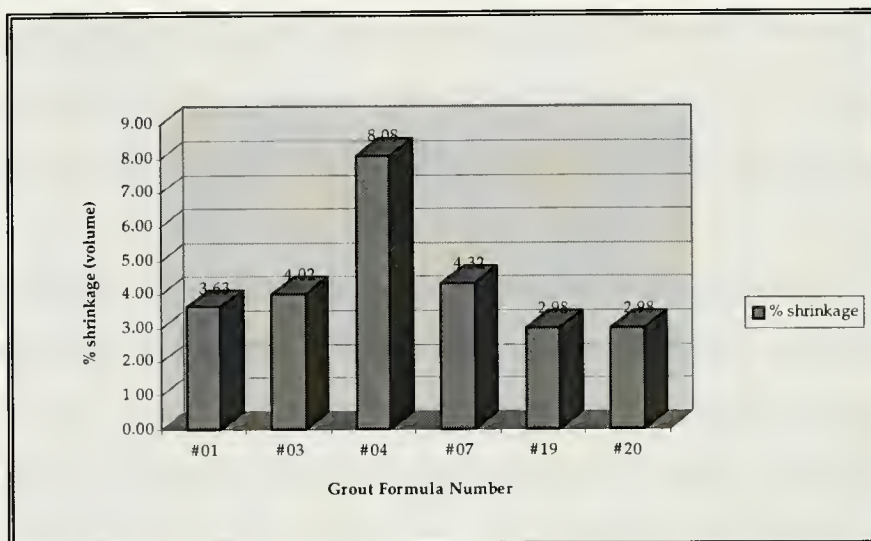
Figure 12. Graph of percent shrinkage test results

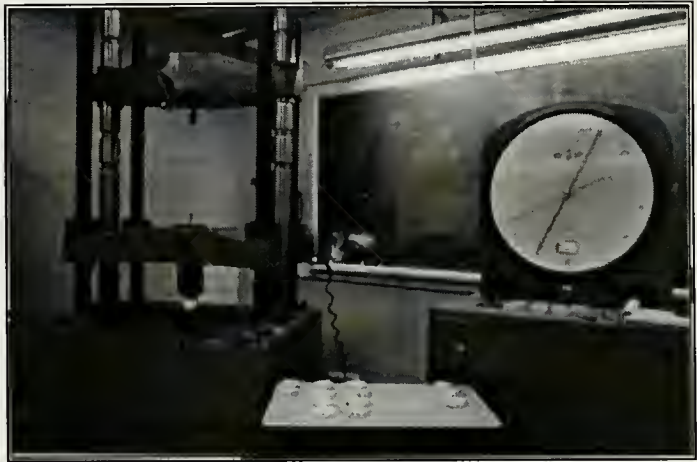
Figure 13. Instron Testing Machine 1331 with a Tinus Olsen Select Range Indicator for testing splitting tensile strength. Note the grout disk loaded in the press, and broken grout samples on the table in the foreground

The splitting tensile strength test was performed in the Materials Testing Laboratory at the University of Pennsylvania using an Instron Testing Machine 1331 with a Tinus Olsen Select Range Indicator. The machine has a universal type load that can be applied with a constant but adjustable rate of cross head movement. To conduct the test, a cylindrical disk of grout was set with its axis horizontal between the platens of the testing machine, balanced on the lower platen by wooden wedges approximately $1 \times \frac{1}{8}$ " in size. Force was applied to

the specimen from above at a load rate of 1 inch per minute. The force required to fracture the specimen was measured and recorded, and then a mathematical determination of indirect tensile strength was calculated using the following formula:

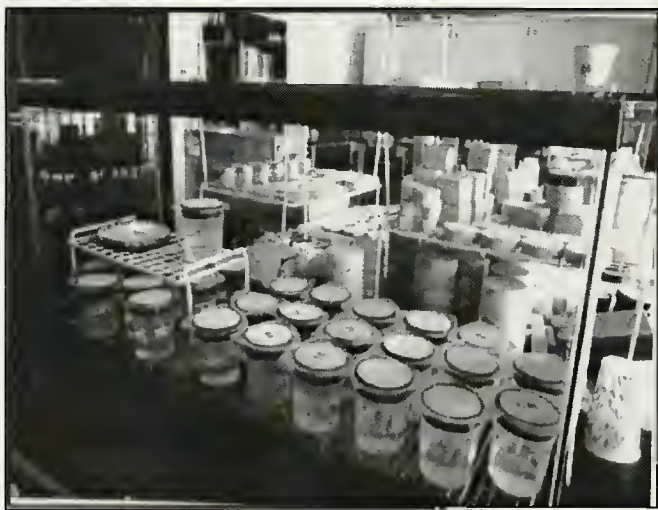
Figure 15. Water vapor transmission testing chamber with grout and adobe samples under testing

Using the standard water method, a grout or adobe specimen was sealed with paraffin over a beaker of distilled water and placed in a sealed, climate and humidity controlled glass

chamber²⁸. Three dish assemblies were made for each six grout types. One "dummy" dish assembly, made by sealing a sample over a dish without water, was made for each specimen type and served as a control. The dish assemblies were weighed daily on an electronic scale with a sensitivity of 0.01g and recorded and corrected using the dummy assemblies. After the

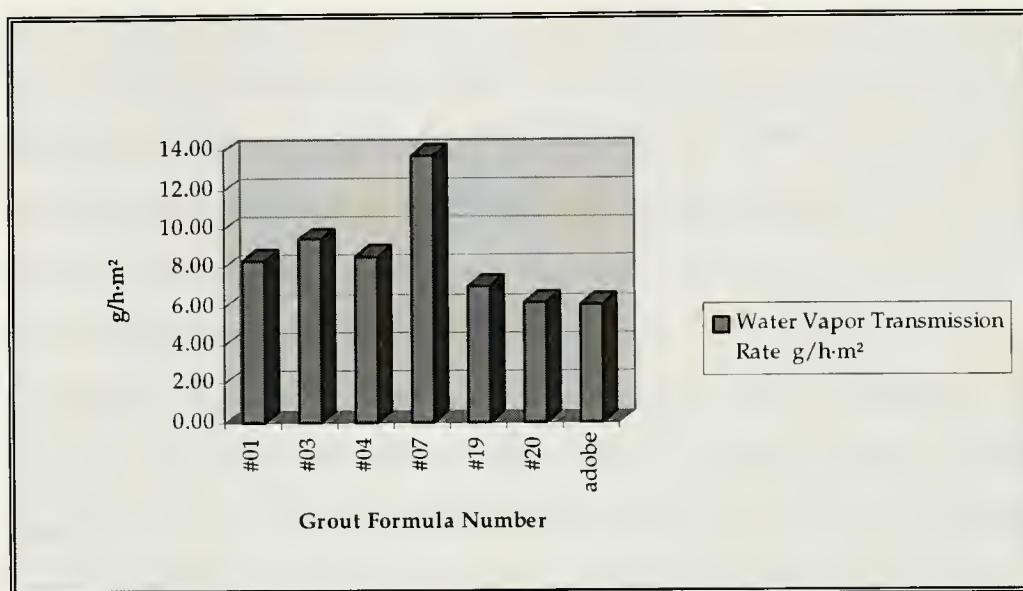
Figure 16. Graph of relative water vapor transmission rates

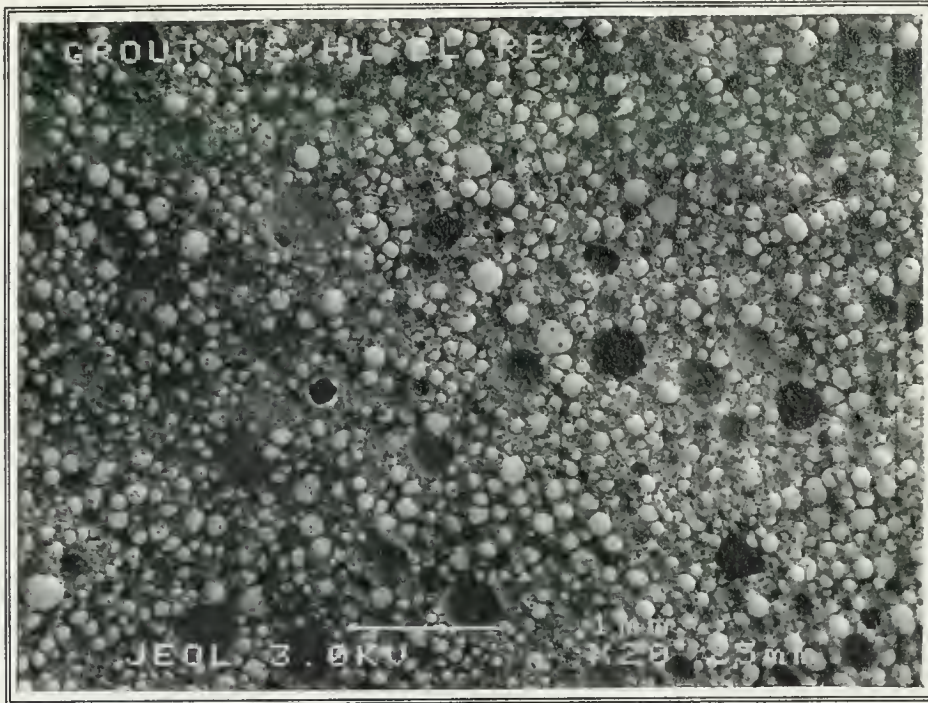
Figure 17. SEM photomicrograph of grout formula #20, showing a well dispersed matrix of ceramic microspheres and hydraulic lime. The vacuoles are a result of the El Rey acrylic additive foaming during mixing. White scale bar length is 1mm. (20x)

At magnifications of 20x and 150x the SEM photomicrographs clearly show the structure of the cured grouts to be homogeneous and uniform. One can clearly see the ceramic microspheres, and in some cases sand, tightly packed together and incorporated in the hydraulic lime matrix. The microspheres appeared to be broadly and well dispersed throughout the sample, with no obvious differential settlement of the heavier particles. For the most part, the individual microspheres and sand grains were thoroughly coated and surrounded by the hydraulic lime binder.

It was apparent that formulas #19 and #20, which included the acrylic emulsion additive, had a high percentage of entrained air visible as discrete vacuoles or pores. These small air bubbles dispersed throughout the hardened grout were produced in moderation by foaming of the acrylic during high speed mixing. There are advantages and disadvantages to these air bubbles. The advantages are that small air bubbles make the grout lighter by reducing the unit weight, increasing moisture transmission through the network of open pores, and may improve freeze-thaw capabilities by providing space for water to migrate and for ice crystals to grow without imposing stress. The disadvantage of air bubbles is that the resulting voids reduce the surface area available for bonding, and decrease the density, which can affect tensile and compressive strength.

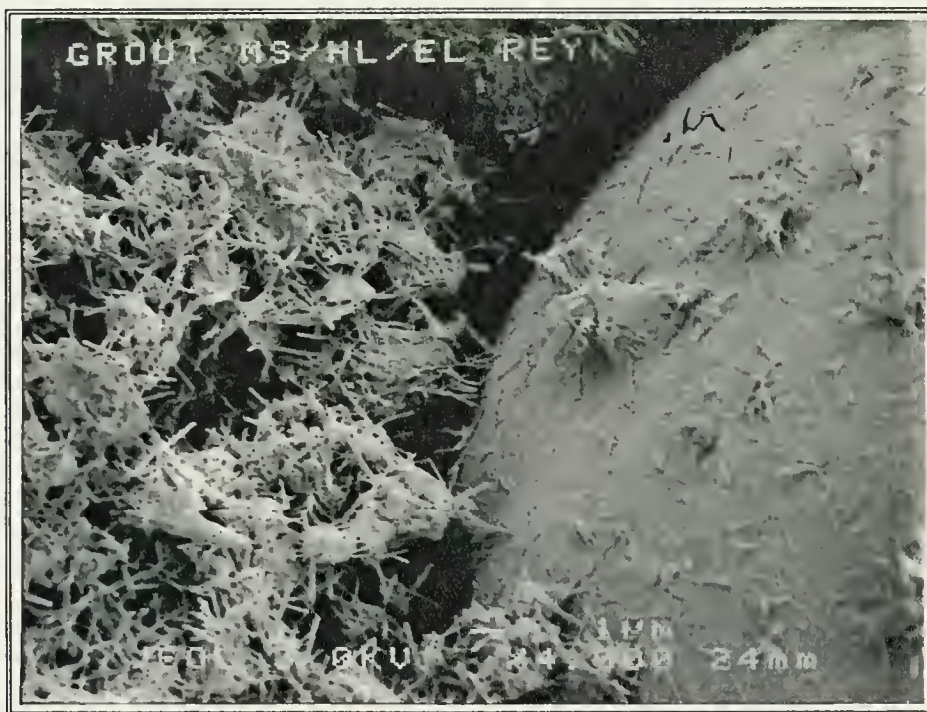
Figure 18. SEM photomicrograph of cured grout formula #20. Notice the acicular needles projecting from the surface of the hydraulic lime particles and the ceramic microsphere on the right. White scale bar measures 1 micron

At 4,000x magnification the hydraulic lime paste can be seen as a film on the microspheres. At this magnification, examination of samples #19 and #20 with the El Rey acrylic emulsion revealed a lattice of acicular needle-like forms extending from the surface of the particles. At first, it was assumed that these formations might be stringers of acrylic emulsion, but after discussion with Getty Conservation Institute scientists Carlos Navarro and Eric Hansen, it was decided that the needles are not amorphous strands of acrylic, but are instead crystalline, possibly formed as a result of the acrylic additive.

Identification of the crystalline material, if it is indeed crystalline, was not conducted, but could be by using X-ray Diffraction. To answer how, and to what extent the addition of the acrylic additive affected crystal growth requires more detailed study. Many variables can alter crystal growth mechanisms in cements (extent of hydration, age, curing conditions, water to binder ratio (Lewin 1982, 121) and impurities in the mix³⁰. It is assumed that the acrylic additive affected the mechanical rather than chemical character of the grout, since the acrylic sets by coalescent film formation, rather than by chemical reaction.

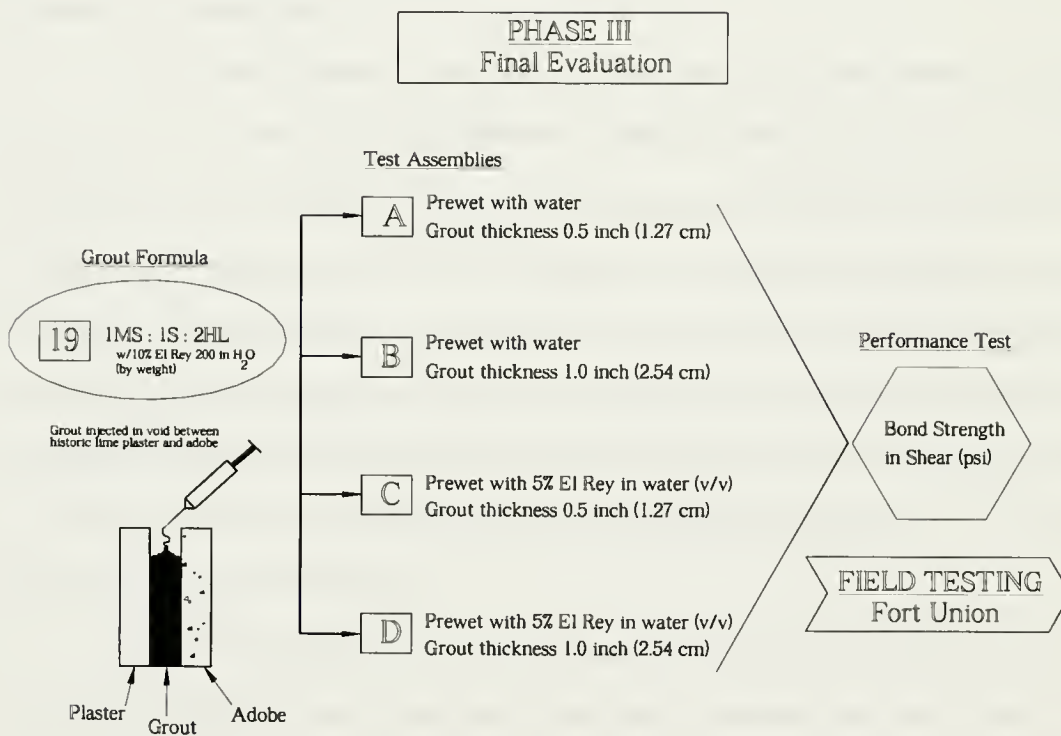
Figure 19. Phase III activity flow chart

The objective of Phase III was to assess the adhesive capability of the selected grout in the laboratory under simulated conditions of use. The grout formula, MS : 1S : 2HL (by weight) with 10% El Rey in H₂O(v/v), was injected between historic Fort Union lime plaster and adobe samples and allowed to cure. Despite problems with the adobe-plaster half of the assemblies, the grout-plaster half was tested for adhesive bond strength in shear by compressive loading.

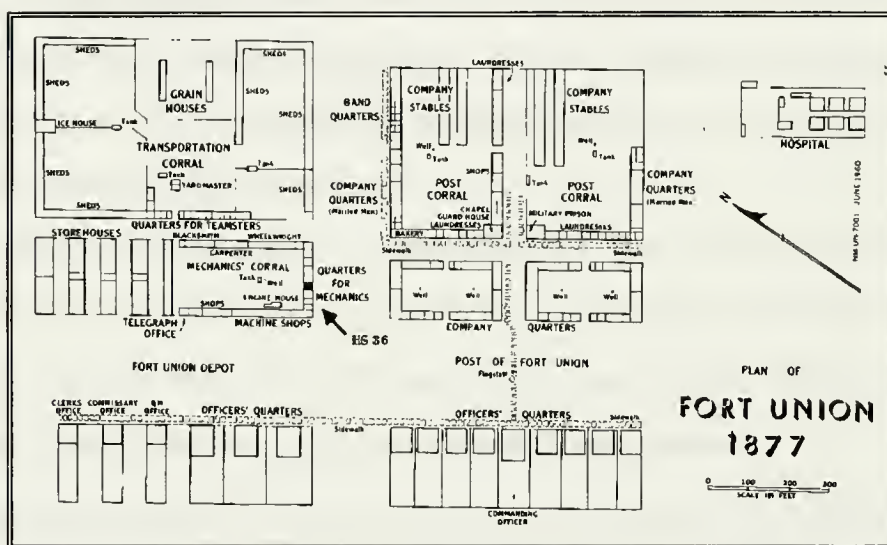
Figure 20. Plan of Fort Union from 1877. The treatment area was in HS 36, known as the Mechanics Corral.

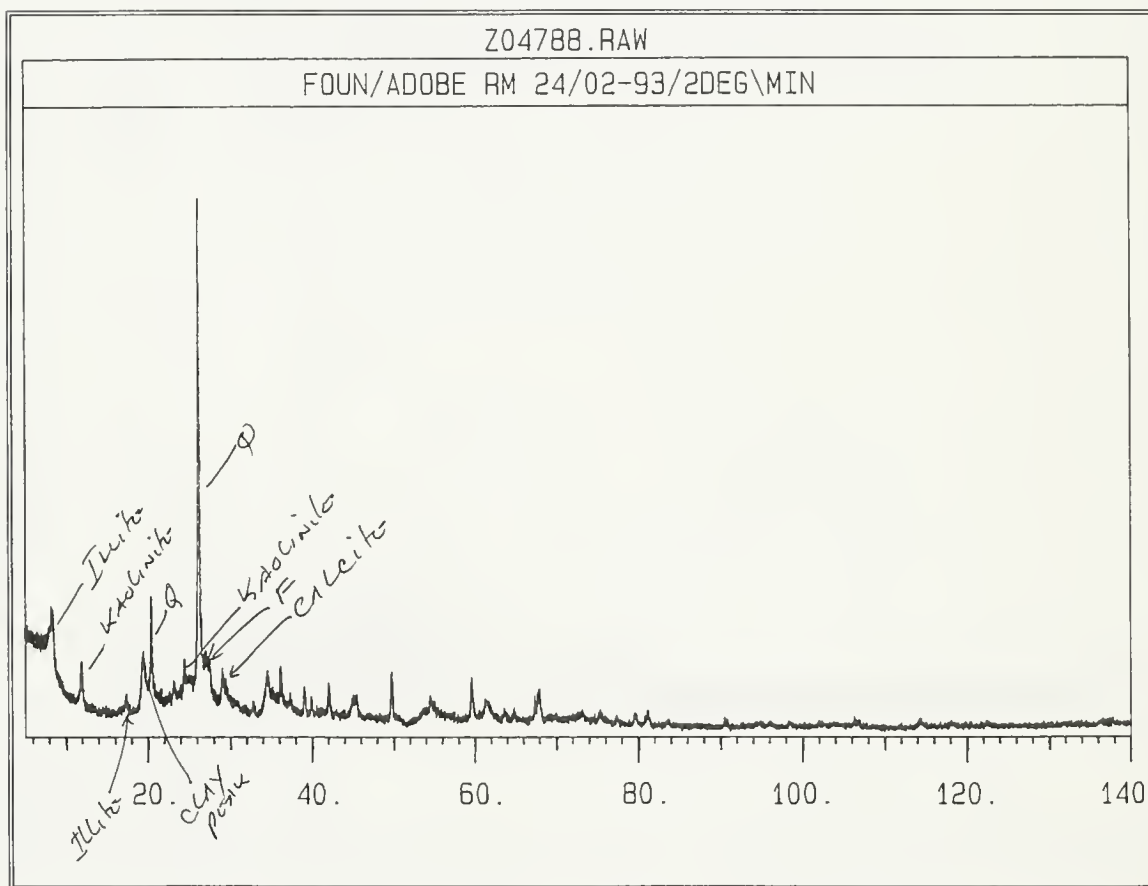
Figure 21. XRD diffractogram of adobe sample HS 36. Annotations by George Austin, New Mexico Bureau of Mines and Mineral Resources

Table 7 lists the minerals found in the order of concentration. Diffractograms are included in Appendix A.

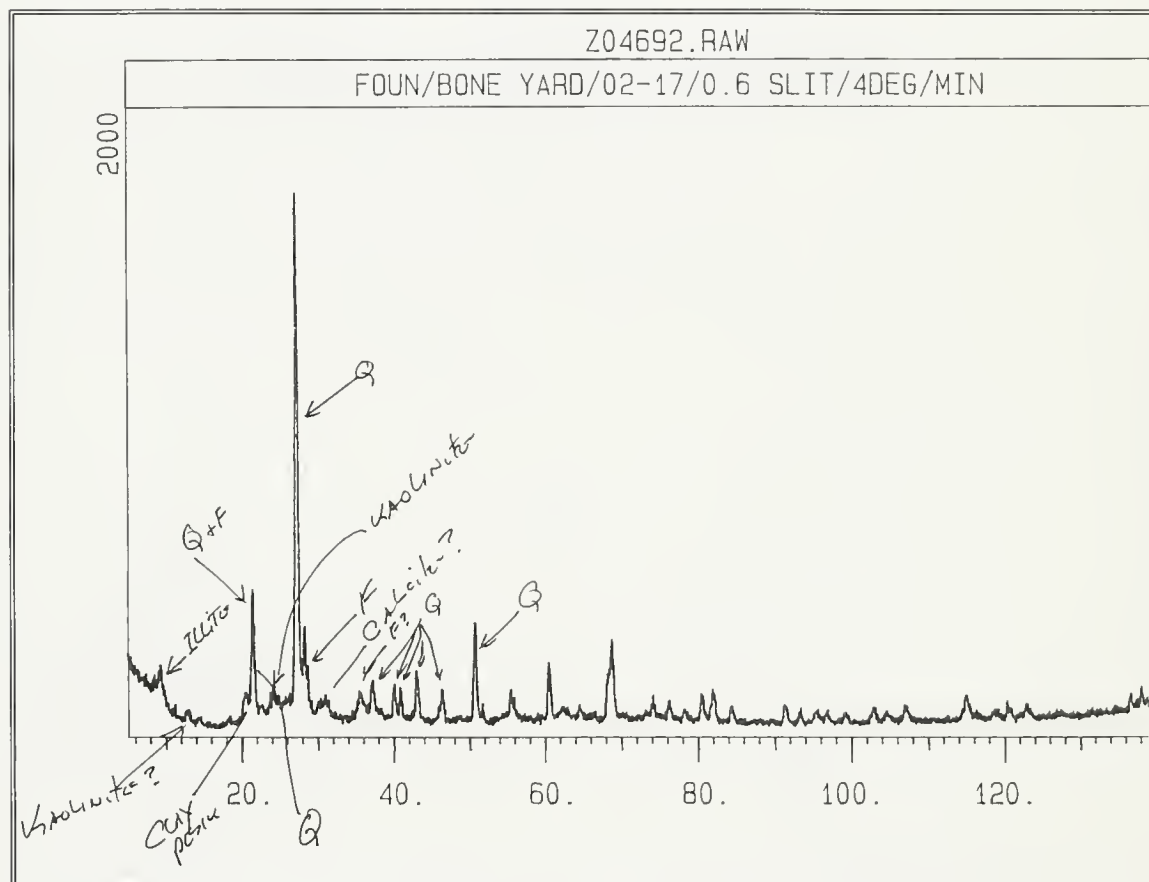
Figure 22. XRD diffractogram of the Boneyard adobe sample. Annotations by George Austin

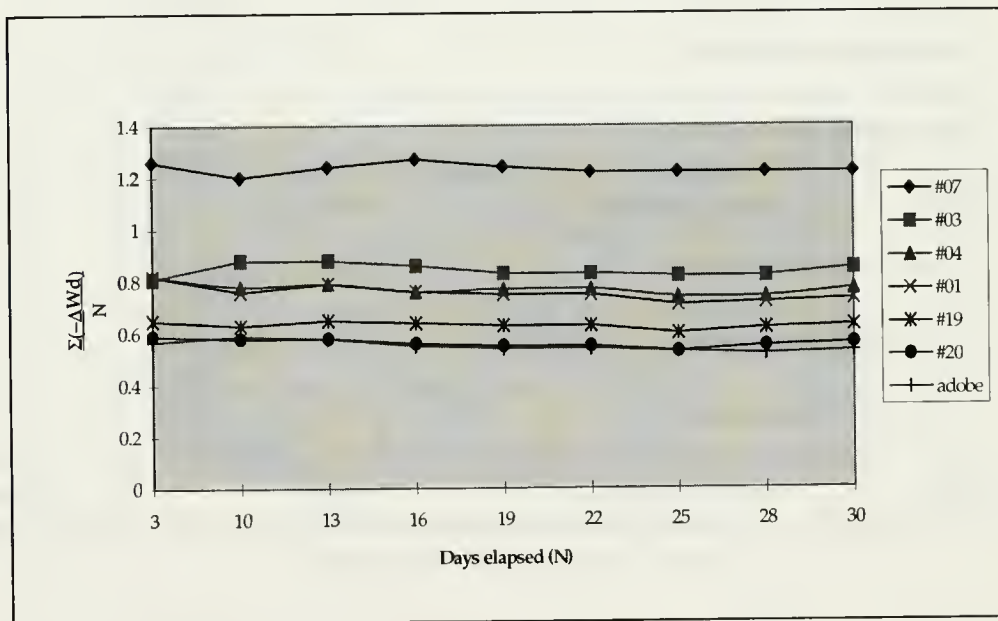
Figure 24. Graph of water vapor transmission data - corrected average weight loss (g/day) over a 30 day period

#01 1MS : 1HL; #03 1MS : 1S : 2HL; #04 1MS : 1S : 4HL; #07 1MS:3.7S:2.5HL w/20% Rhoplex E-330 in H₂O;
 #19 1MS : 1S : 2HL; w/ 10% EL Rey in H₂O; #20 1MS : 1HL w/ 10% EL Rey in H₂O (ratios by weight)

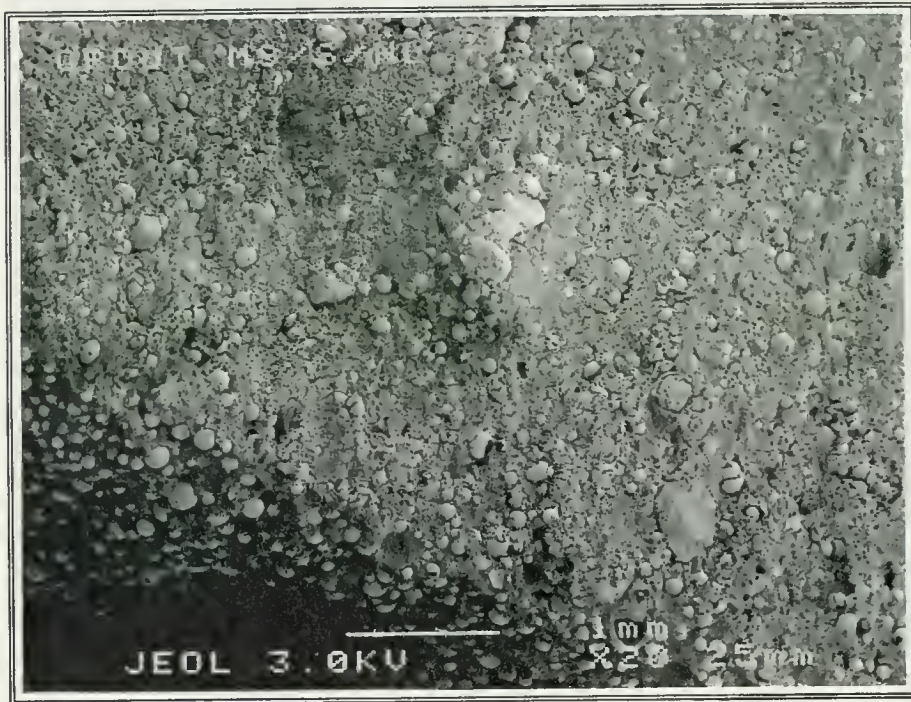
Figure 25. Grout formula #03 composed of 1MS:1S:1HL (w). The large, irregular sized particles interspersed between microspheres and hydraulic lime are sand grains. White scale bar equals 1 mm. (20x)

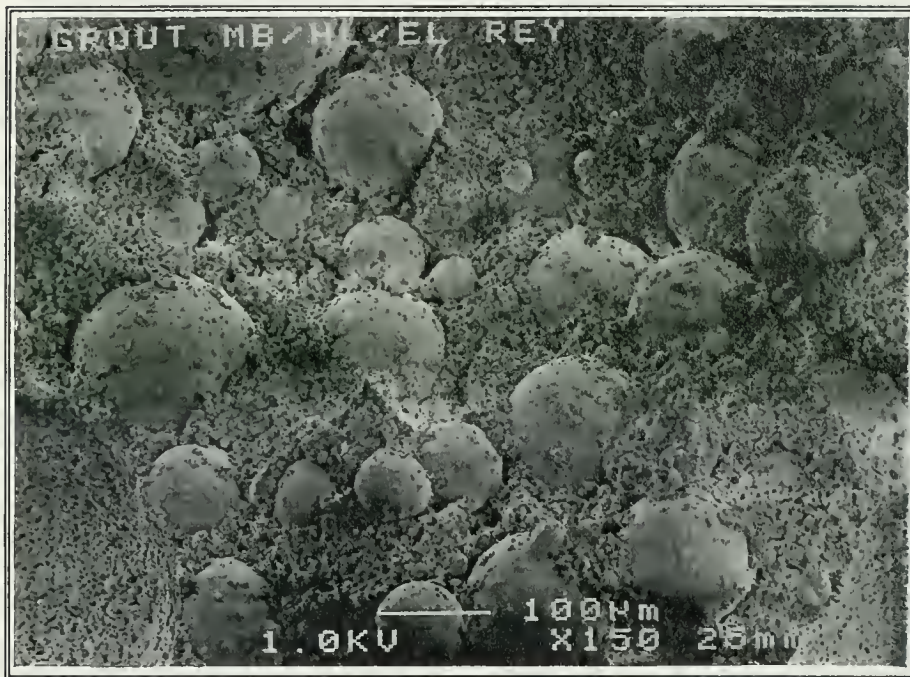
Figure 26. Grout formula # 20 (#01 amended with a 10% acrylic emulsion in H_2O) at 150x. Notice how the well dispersed individual microspheres are thoroughly surrounded by the hydraulic lime matrix.

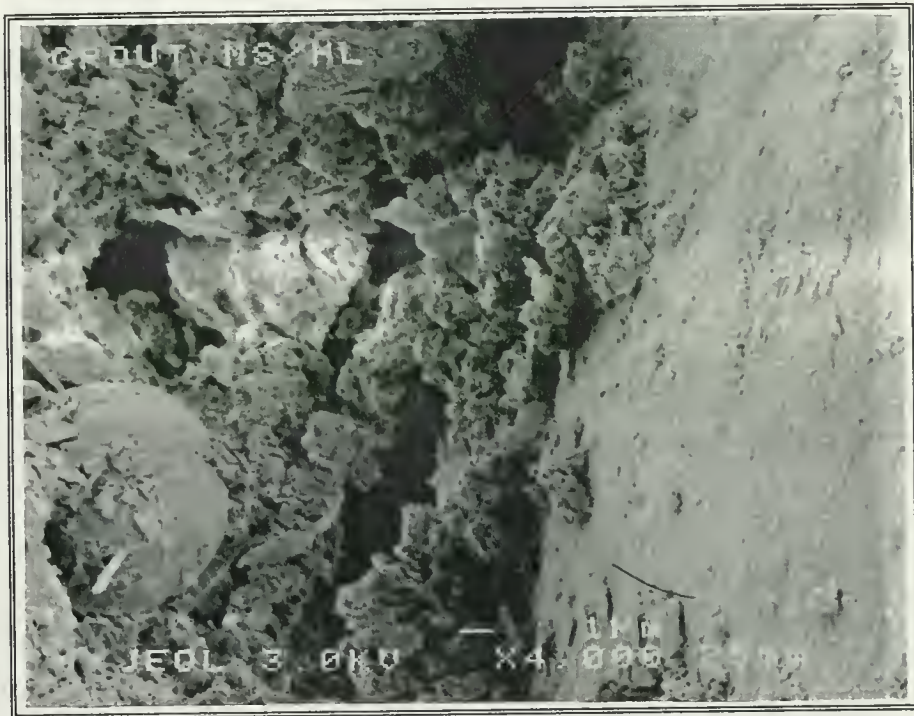
Figure 27. Grout formula #01 composed of 1MS:1HL (w) at 4,000x. A large microsphere is seen on the right, and a smaller sphere on the left. Hydraulic lime fills the space in between. White scale bar measures 1 micron.

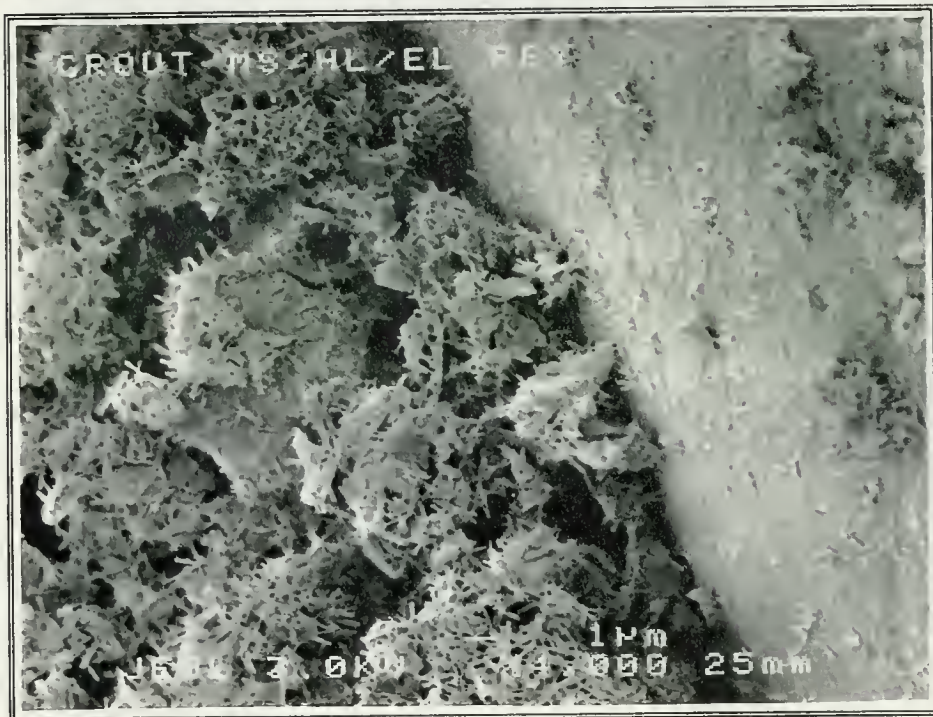
Figure 28. Grout formula # 20 (#01 amended with a 10% acrylic emulsion in H₂O) at 4,000x. The mass on the right is a microsphere; the adjacent platelets are hydraulic lime. Note acicular needle-like formations projecting from the particle surfaces. The needles may be crystalline and may have formed as a result of the acrylic additive.

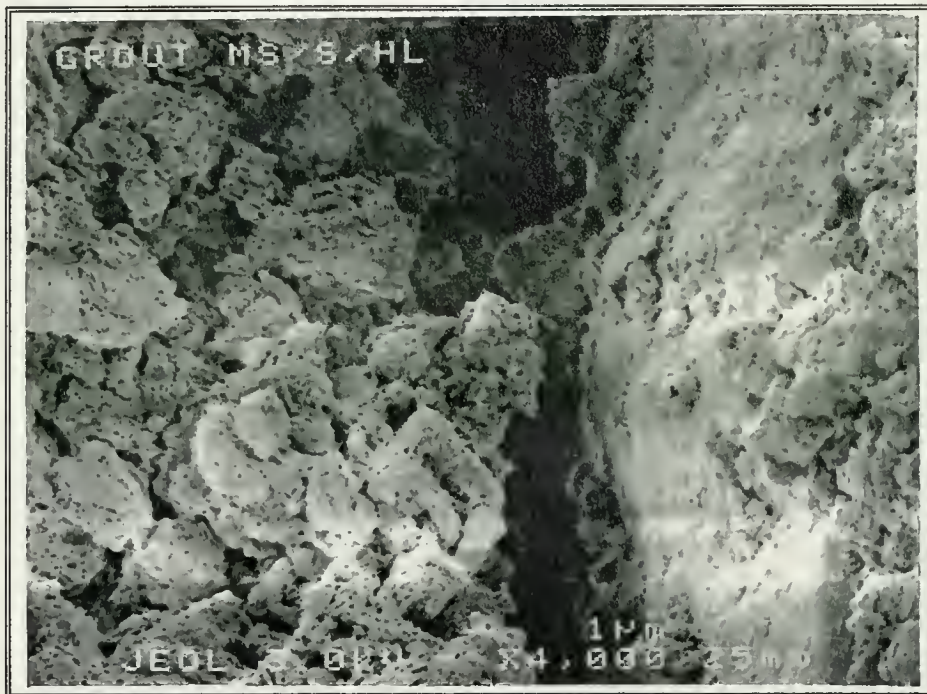
Figure 29. Grout formula #03 composed of 1MS:1S:1HL (w). Hydraulic lime can be seen coating the surface of the microsphere, but in this case, it does not appear to be well bonded to the sphere. White scale bar equals 1 micron. (4,000x)

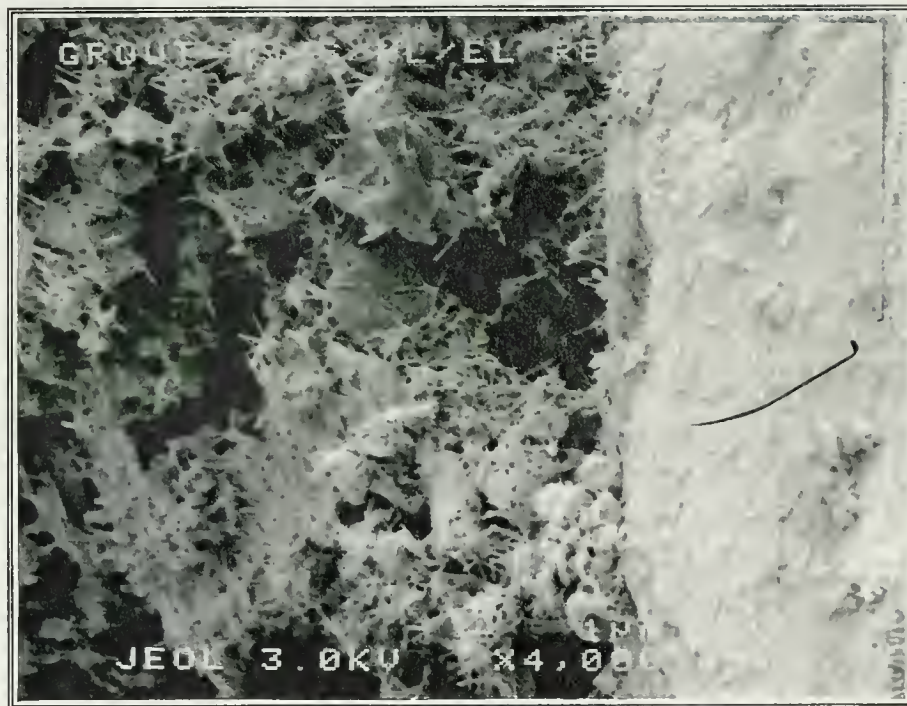
Figure 30. Grout formula #19 composed of 1MS:1S:1HL with a 10% aqueous acrylic emulsion at 4,000x. Again, the needle like projections appear in the acrylic modified grout. The hydraulic lime appears to be well attached to the microsphere or sand grain on the right.
